Empire State Building

Elevators, Modernization

Otis is chosen again for a showcase elevator (and more) in the iconic skyscraper.

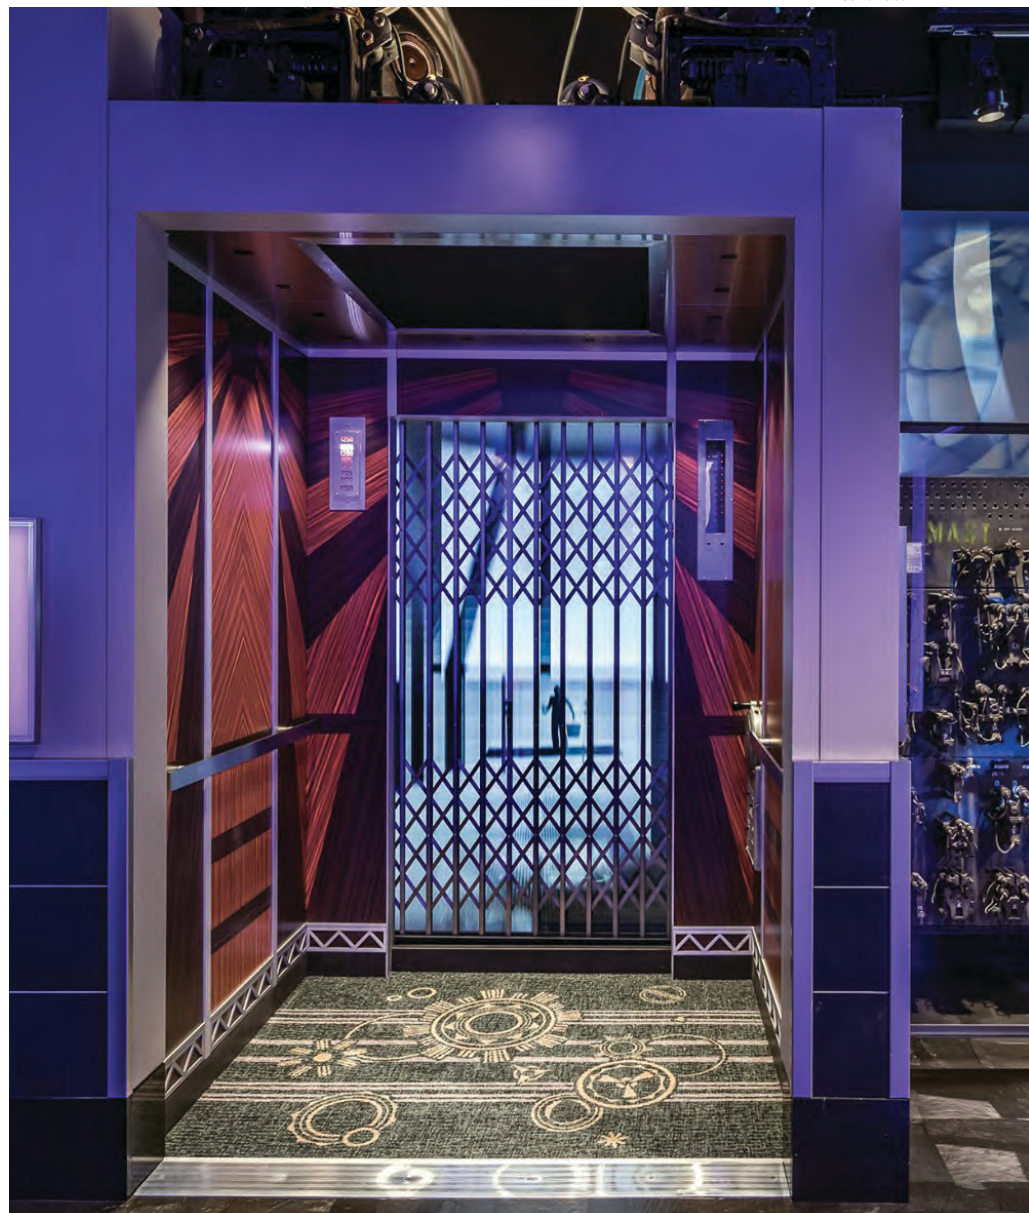
A model of the original mast car is now on display in the building's second-floor exhibit (ELEVATOR WORLD, December 2019). Its back wall is animated to simulate an actual ride to the 102nd floor.

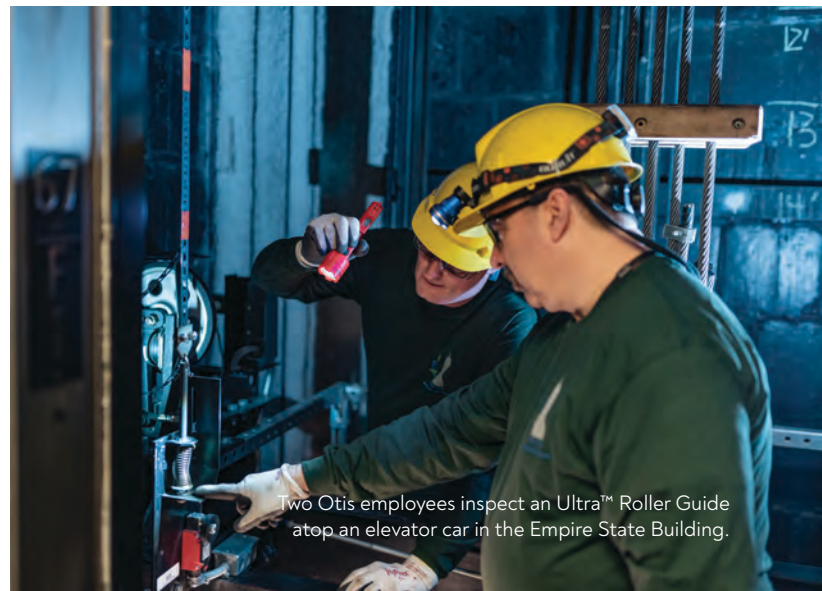
Two Otis employees inspect an Ultra™ Roller Guide atop an elevator car in the Empire State Building.
